Porsche 911 Convertible Top Locking Motor Gear Replacement Instructions 911-624-056-03K

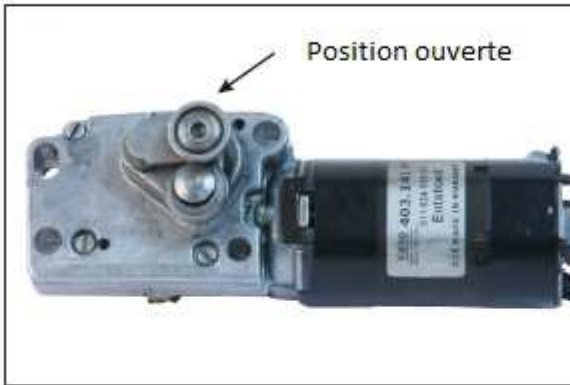
Commencez par retirer le moteur de capote avec le toit en position ouverte.

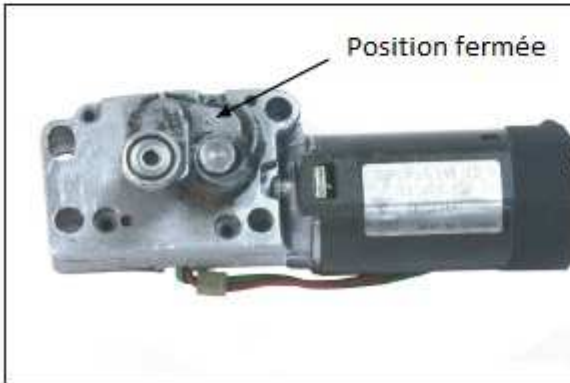
Retirer les 4 vis du couvercle puis à l'aide du tournevis tourner l'axe pour que le mécanisme soit en position ouverte.

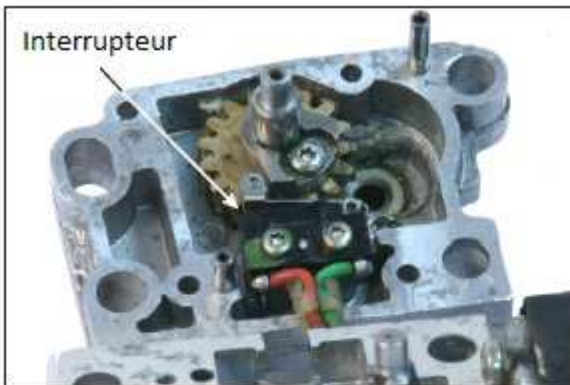
Retirer avec précaution le couvercle laissant apparaître le mécanisme et l'interrupteur sans changer sa position.

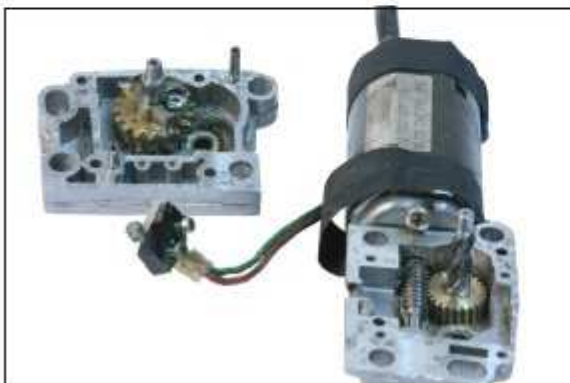
Retirer les 2 vis Torx (T9) de l'interrupteur afin de dissocier les deux parties du moteur.

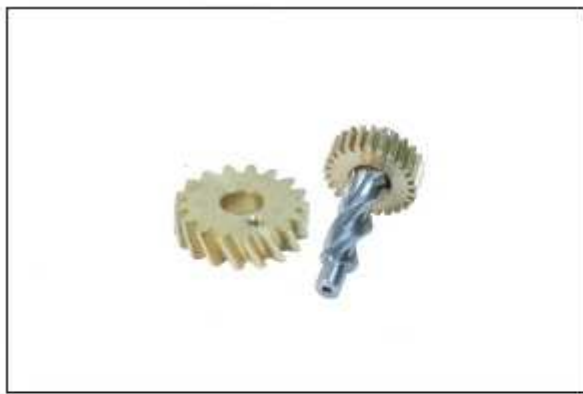
← Le kit de réparation se présente comme ceci.

Veillez remplacer les deux éléments même si un seul est endommagé afin d'éviter une usure prématurée.

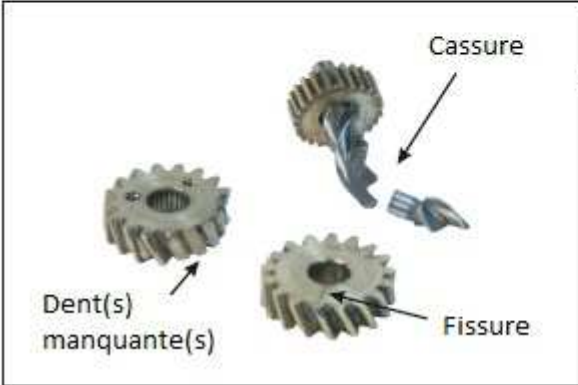
← Voici les problèmes que vous pouvez rencontrer.

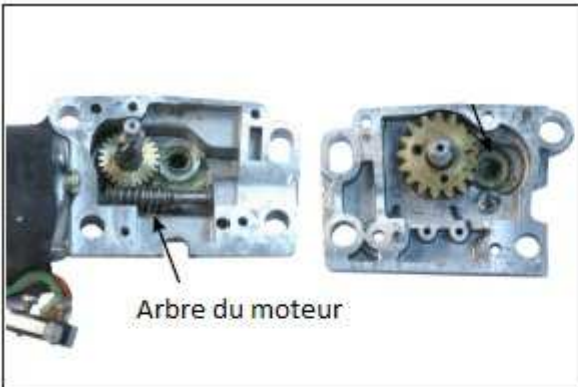
Attention : Si l'arbre qui entraîne le pignon est cassé, il est nécessaire de remplacer le moteur.

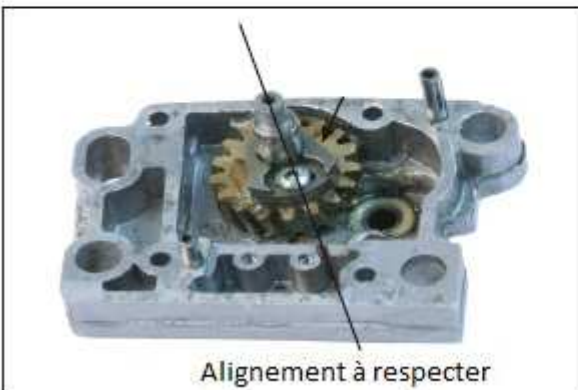
Alignez les pièces comme sur le schéma et tracer une marque.
Il faudra remonter les pièces dans la même position.

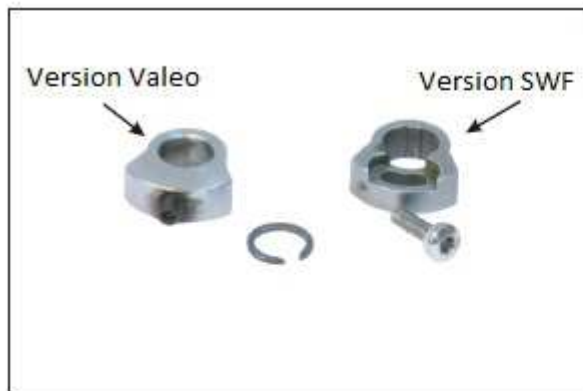
Deux types de cames existent, elles dépendent de la marque du moteur.

Sur la version Valeo, la came est maintenue sur l'arbre par un circlip et une vis.

Sur la version SWF, la came est vissée sur le pignon.

Le kit de remplacement convient aux 2 versions.

Desserez et retirez l'ancien pignon. Puis, remontez le nouveau pignon dans la même position. Servez-vous des marques d'alignement que vous avez faites précédemment.

Graissez les pièces.

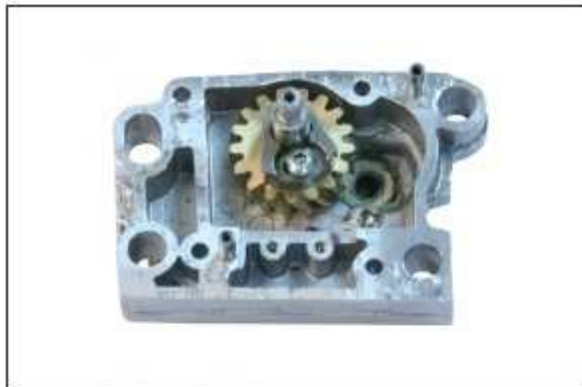
Réinstallez l'interrupteur en vous assurant de toujours être en position ouverte.

Quelques ajustements peuvent être nécessaires.

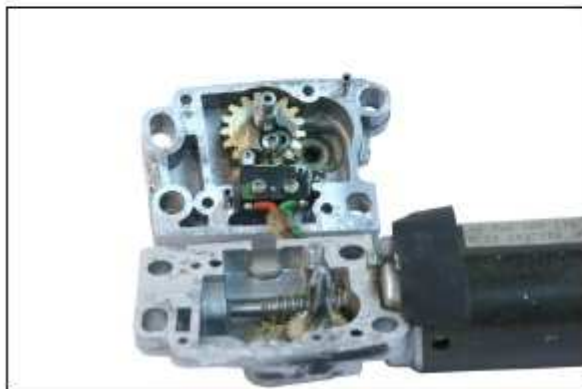
Basculez le mécanisme en position fermée pour vous assurer que l'interrupteur soit en butée.

Si ce n'est pas le cas, réajustez la position de la came.

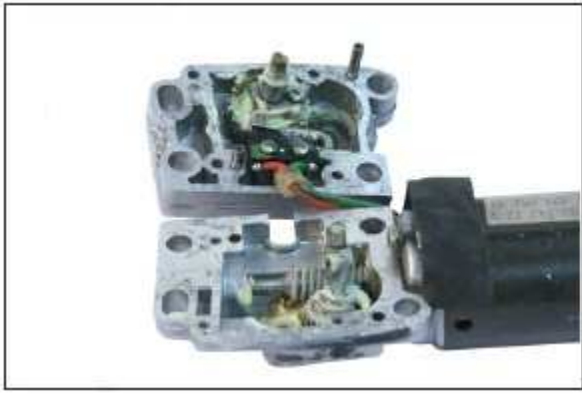
Installez le second nouveau pignon sur vis sans fin et graissez.

Refermez et vissez le couvercle avec le mécanisme en position ouverte.

Remontez le moteur sur le véhicule.

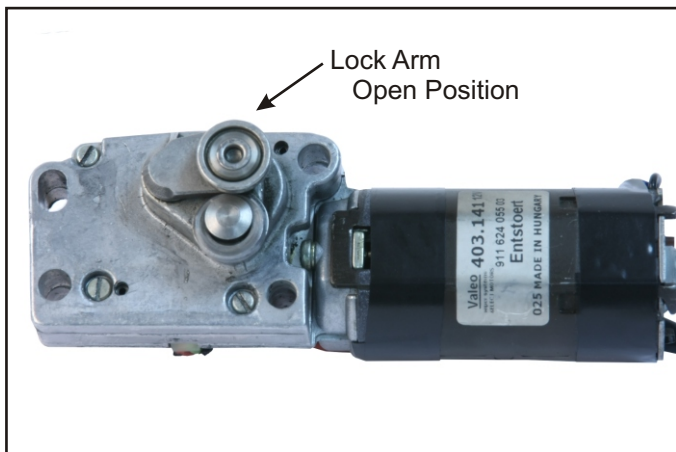
Starting with the top in the open position and remove damaged motor from car.

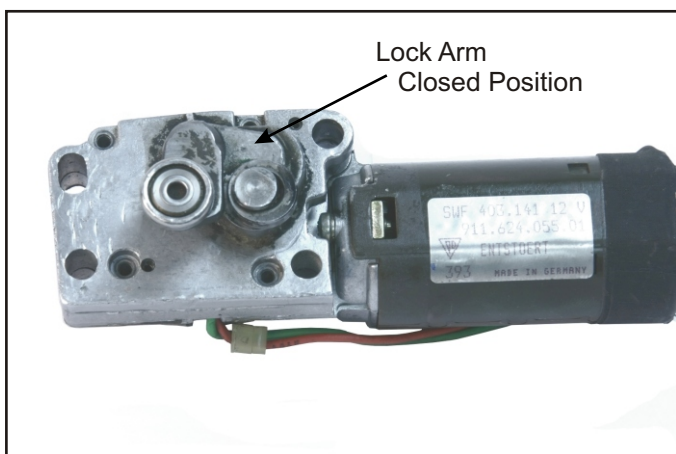
Remove 4 slotted screws on lock lever cover and using the manual drive screw on the back of the motor turn until top locking lever is in the fully open position.

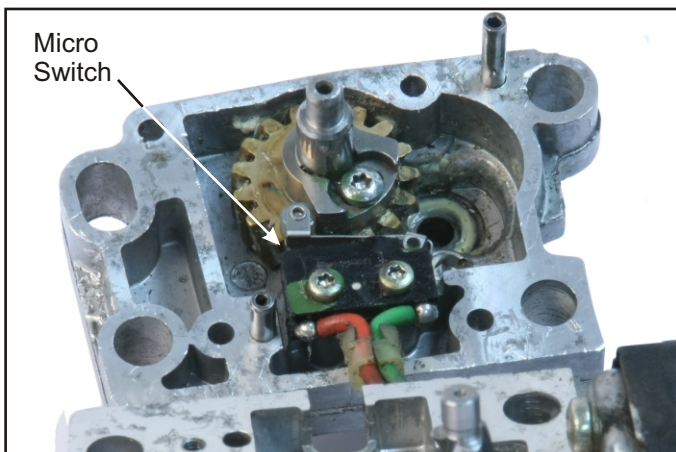
Carefully pry off upper cover exposing the gear set and micro-switch taking care not to change the lock arm position. **Note:** the locking arm will move freely once the gears disengage.

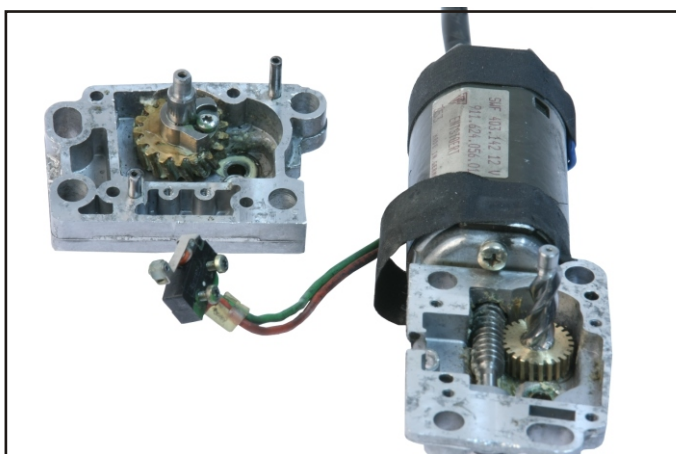
Remove (2) T9 Torx screws holding micro-switch in place, separating the lock cover and driven gear from the motor assembly.

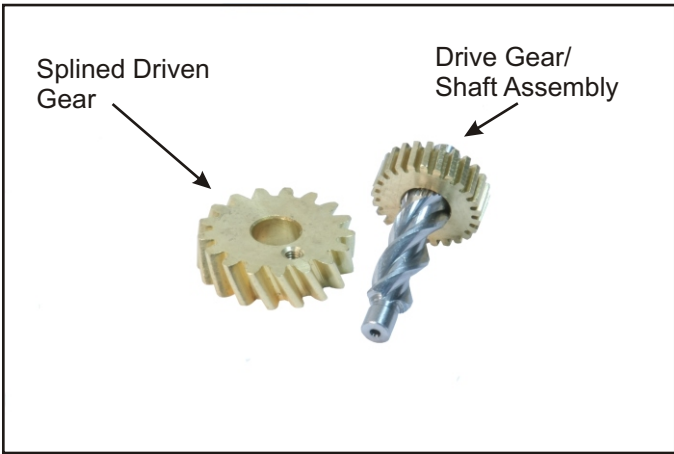
The new gears are supplied as a match set.

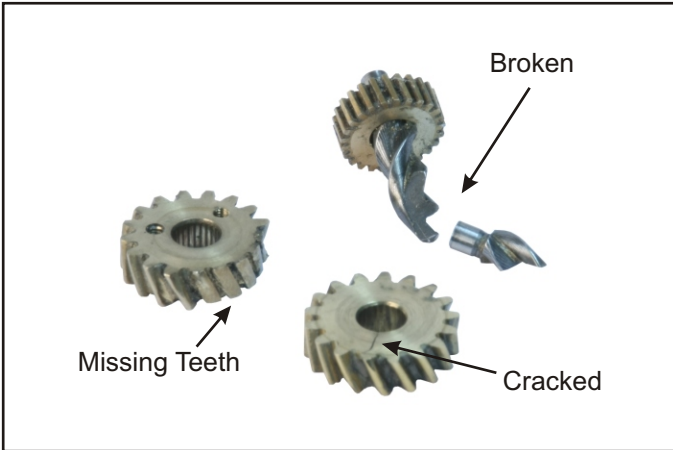
Both must be replaced and not only the damaged gear. The drive gear/shaft assembly and driven lever operating gear are subject to multiple types of failures.

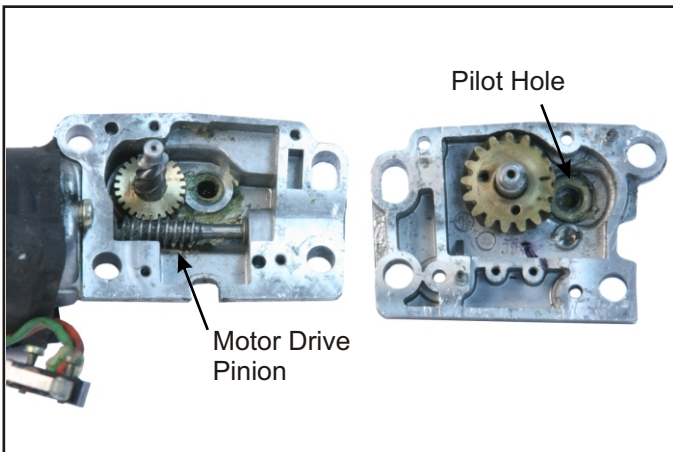
Note: If upon opening the cover the motor pinion worm gear on the motor shaft is broken the entire motor assembly will need to be replaced as this is not serviceable.

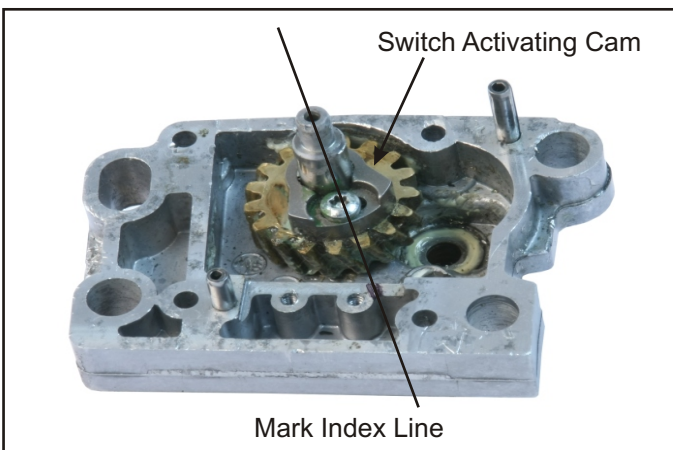
Put an indexing mark for the micro switch activating cam on both the cam centerline and cover body to help with proper reinstallation later. **Note:** Make sure the lock arm is still in the open position. This is critical for timing the motor.

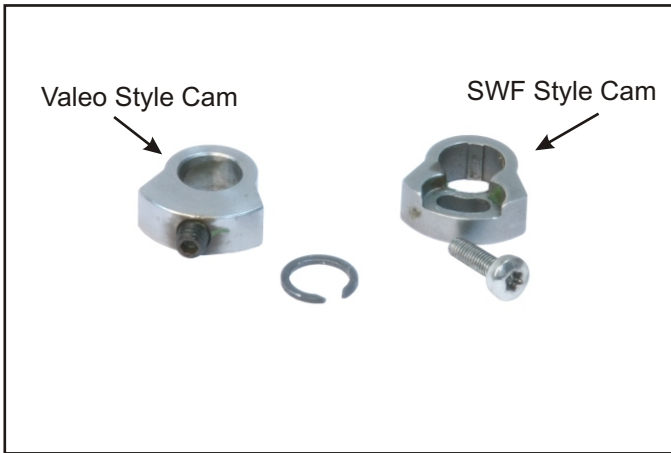
There are 2 types of activating cams depending on the brand of motor in your car. The differences are in how they are secured to the driven gear.

Version #1 found on Valeo motors has the cam retained on the shaft by a circlip and has a set screw on the face of the cam to locate its timing position.

Version #2 found on SWF motors has the cam retained by a set screw from the top of the cam into the driven gear to locate its timing position.

Note: the replacement large driven gear has a mounting hole for the SWF style cam but is suitable for both styles of motors.

Loosen the retaining hardware for the switch activating cam and remove it. Using a suitable press tool, press out the lock arm shaft from the large driven gear taking care not to damage the end of shaft. Note: this shaft is splined to the gear.

Taking care not to lose any of the distance shims under the damaged driven gear, set the new driven gear over the shaft hole making sure the cam locating hole is aligned with the mark made earlier on the housing cover. After lubricating all parts lightly with hi pressure grease (Porsche # 000 043 024 00), press the shaft back through the new driven gear.

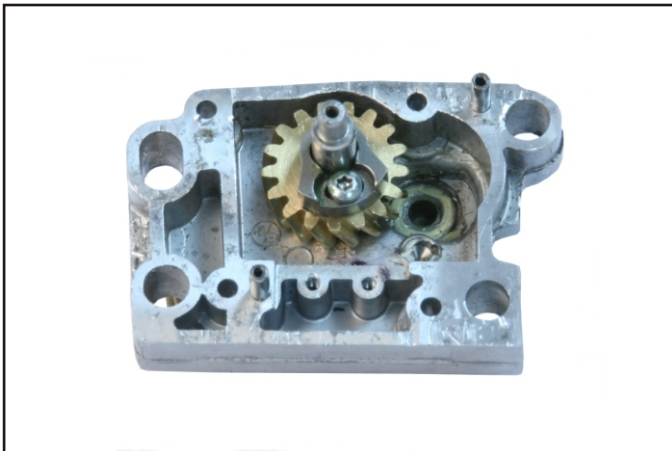
Ensure the locking lever is turned back to the open position and reinstall micro switch cam. Use the indexing marks made earlier to align the cam timing correctly, but only tighten the retaining screw lightly.

Note: Some adjustment maybe necessary later.

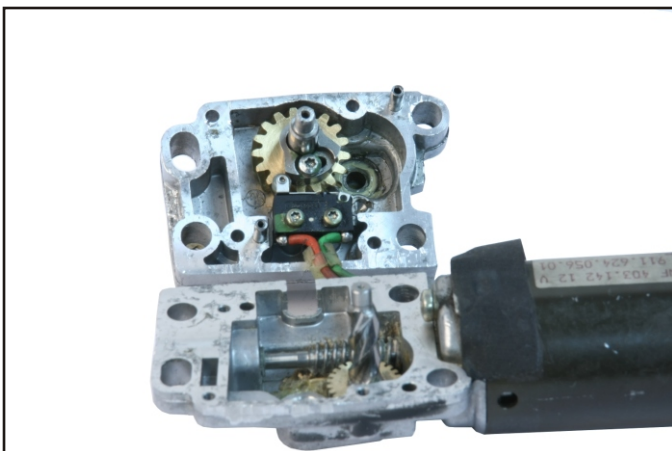
Reinstall the micro switch onto the cover. Move the lock lever from the fully open position to the fully closed position making sure the micro switch is activated at the very end of travel for each cycle. If necessary loosen the screw to move the activating cam to ensure this happens before fully tightening the set screw.

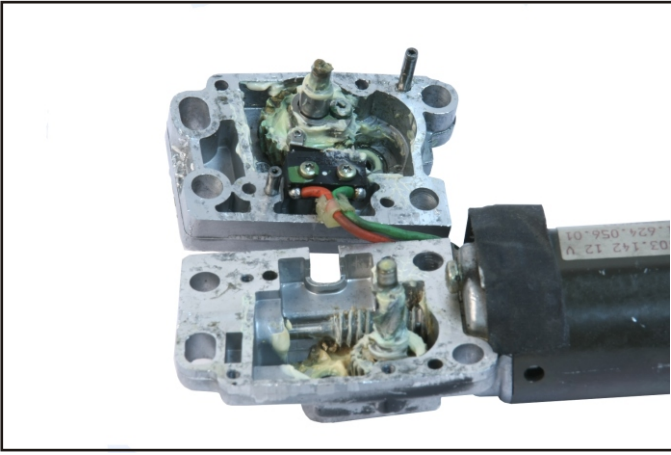
Install new drive gear / shaft assembly making sure it mates properly with motor pinion gear, taking care not to lose any of the distance shims under the old gear if present. Using HP grease (Porsche # 000 043 024 00), grease all new gear teeth and pilot holes.

Reinstall lock arm cover making sure drive gear shaft mates properly into pilot hole in cover and ensuring that lock arm is still in the fully open position.

Tighten 4 cover screws, reinstall on vehicle, and test.
